Single Rod Contraceptive Implant Ultrasound

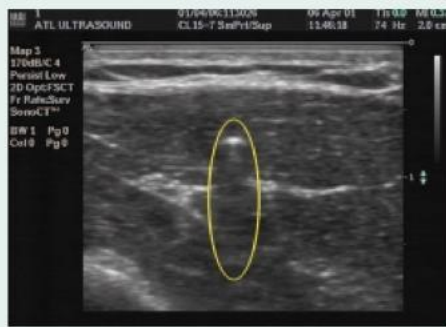
A. 15-7 MHz transducer

Transversal view of an intramuscularly inserted contraceptive implant using five (A-E) different ultrasound transducers. The circle marks the echogenic spot produced by the rod itself and its acoustic shadow in the surrounding tissue

- e. Best results were obtained with the high and very high frequency linear array transducers (12–5 and 15–7 MHz) (Fig. 3). When using a low or intermediate frequency transducer (5 – 2 and 8 – 4 MHz), application of a silicone patch or a large amount of gel was found to enhance visibility

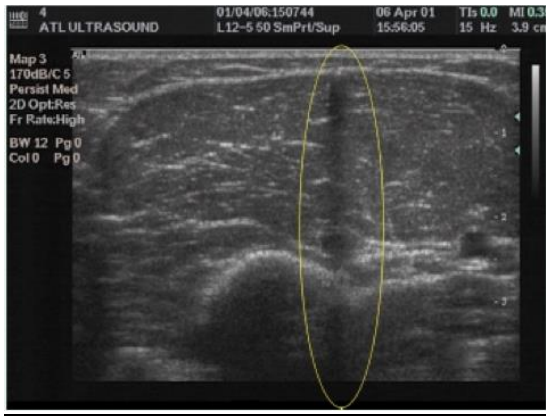
- i. Transversal view of a too deeply, subfascially inserted contraceptive implant using a high frequency (12–5 MHz) linear array transducer. The circle marks the echogenic spot produced by the rod itself and its clear acoustic shadow in the surrounding tissue

- f. The rods can be located intra-muscularly in the m. biceps and just beneath the fascia of the m. biceps, respectively. The distal tip of the implant can be located just underneath the skin while the proximal tip was inserted too deeply indicating an incorrect "injection" technique. For the woman in whom the implant could not be visualized, a negative serum etonogestrel level (i.e. active component of Implanon) can support the ultrasound finding that the implant had not been inserted
