ENDOVASCULAR AORTOILIAC STENT GRAFT

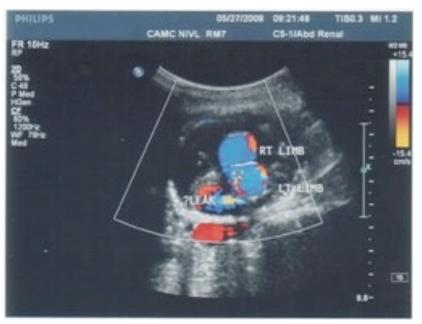
Endograft leak

The most important complication to detect is aneurysm expansion and endoleak that can occur even after successful EVAR (endovascular aneurysm repair) and represents one of the limitations of this procedure. Endoleaks represent blood flow outside the stent-graft lumen but within the aneurysm sac. It occurs in approximately one-fourth of patients. The most common is reversal of flow through aortic branch vessels which then empty into the aneurysm sac.

Endoleak type:

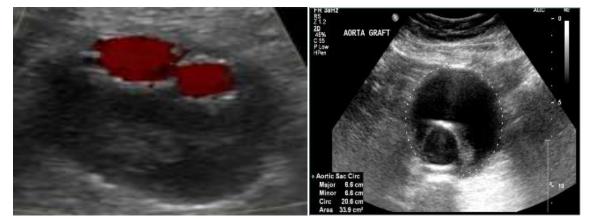
Patent right & left limbs of endograft without leak Ellipse measurement of aneurysm sac

The ultrasound exam consists of measurement of aneurysm size with identification of substantial changes in aneurysm dimensions, detection and, if possible, characterization of an endoleak, and detection of mechanical changes in the stent-graft, including migration, kinking, and fracture.
